Supporting the Nation's Power Grid through Coatings Management

Proactive Coatings Maintenance Plans Abate Corrosion of Aging Electrical Transmission Structures

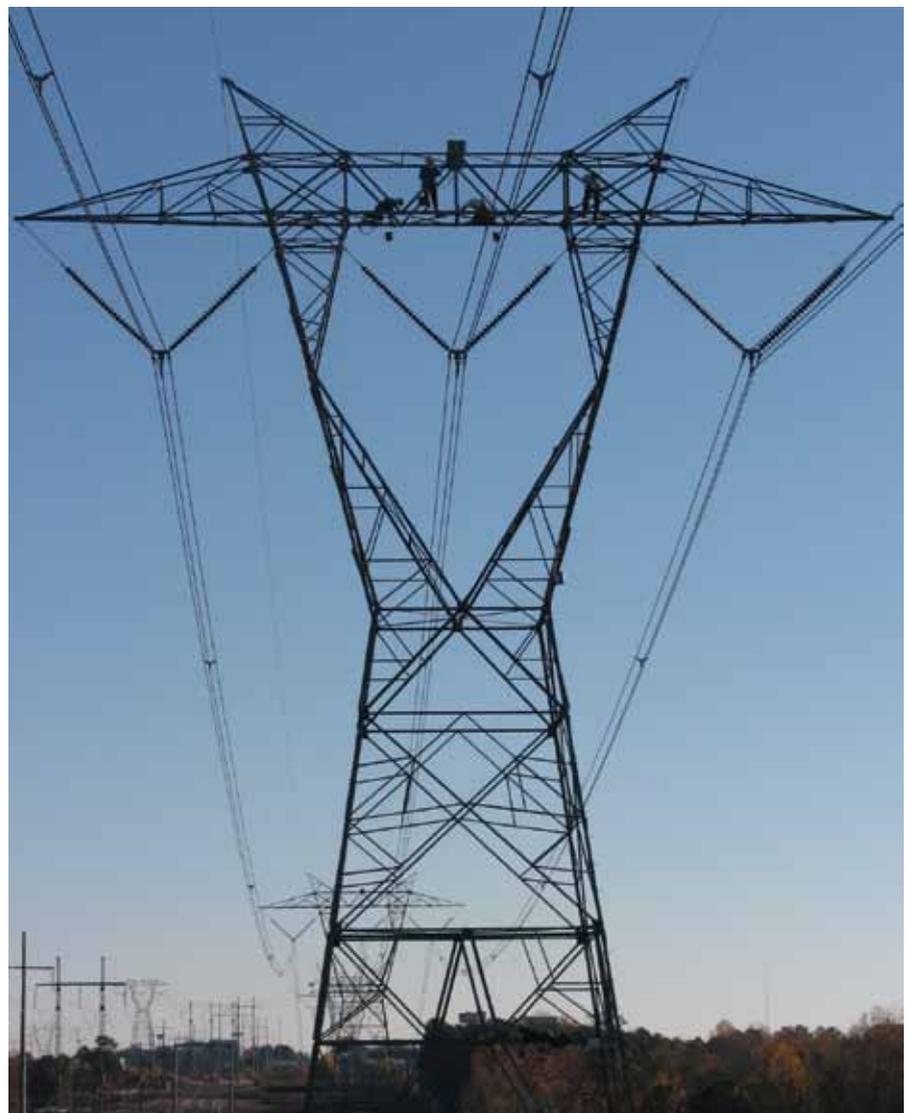
A painting crew coats a galvanized steel tower. Photo courtesy of Curt Hickcox, Public Utilities Maintenance, Inc.

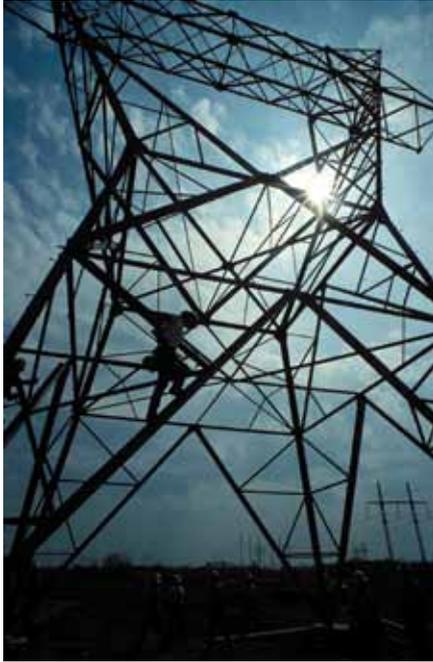
Workers conduct a final inspection of a newly installed galvanized steel transmission tower. Photo courtesy of Alan Holloman, Georgia Power Co.

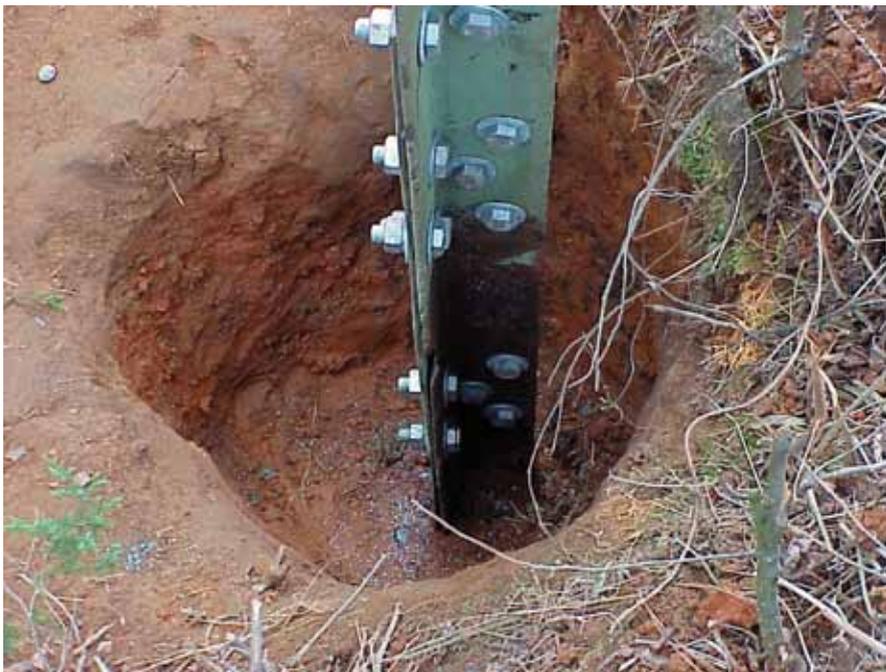
A recently repaired embedded steel footing is shown. Photo courtesy of Alan Holloman, Georgia Power Co.

The ground line inspection, conducted by a specially trained crew, calls for excavating and cleaning embedded steel footings. During a ground line inspection, a structure is rated on a scale of one (like new condition) to five (worst condition) and the data is collected in a hand-held computer. Depending on the rating, the structure is either coated or scheduled for repairs at the transition zone. During the ground line inspection,

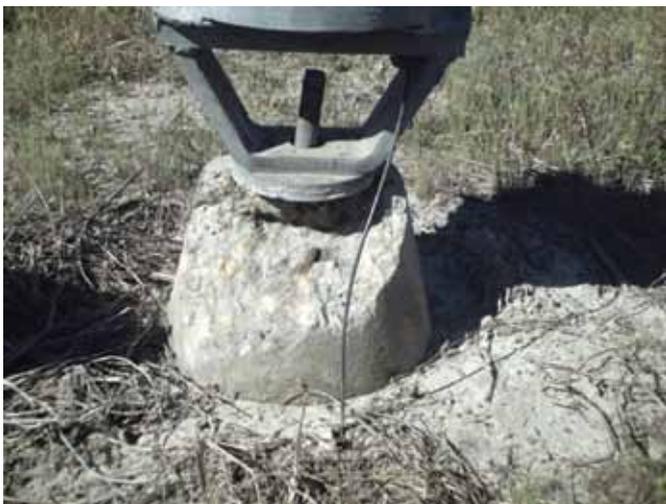
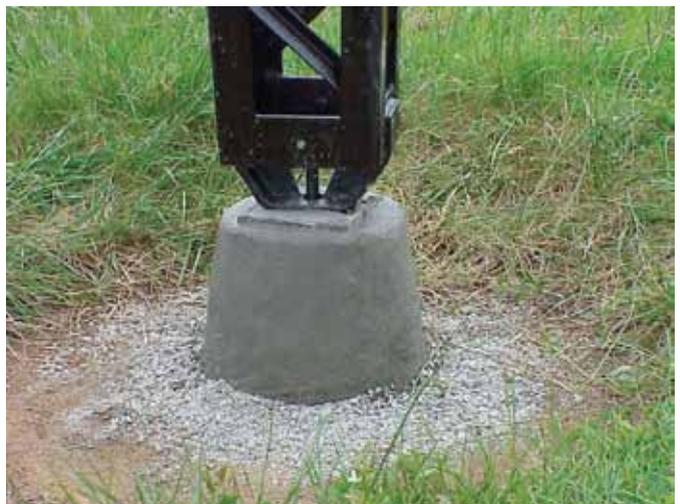
The photos show a broken foundation found during inspection (left) and a repaired foundation with a ground line coating (right). Photo courtesy of Alan Holloman, Georgia Power Co.
